NAVAL FACILITIES ENGINEERING SERVICE CENTER
Port Hueneme, California 93043-4328

Technical Report TR-2040-OCN

FDS-D WET-END SURVIVABILITY POST TEST ANALYSIS

March 1995

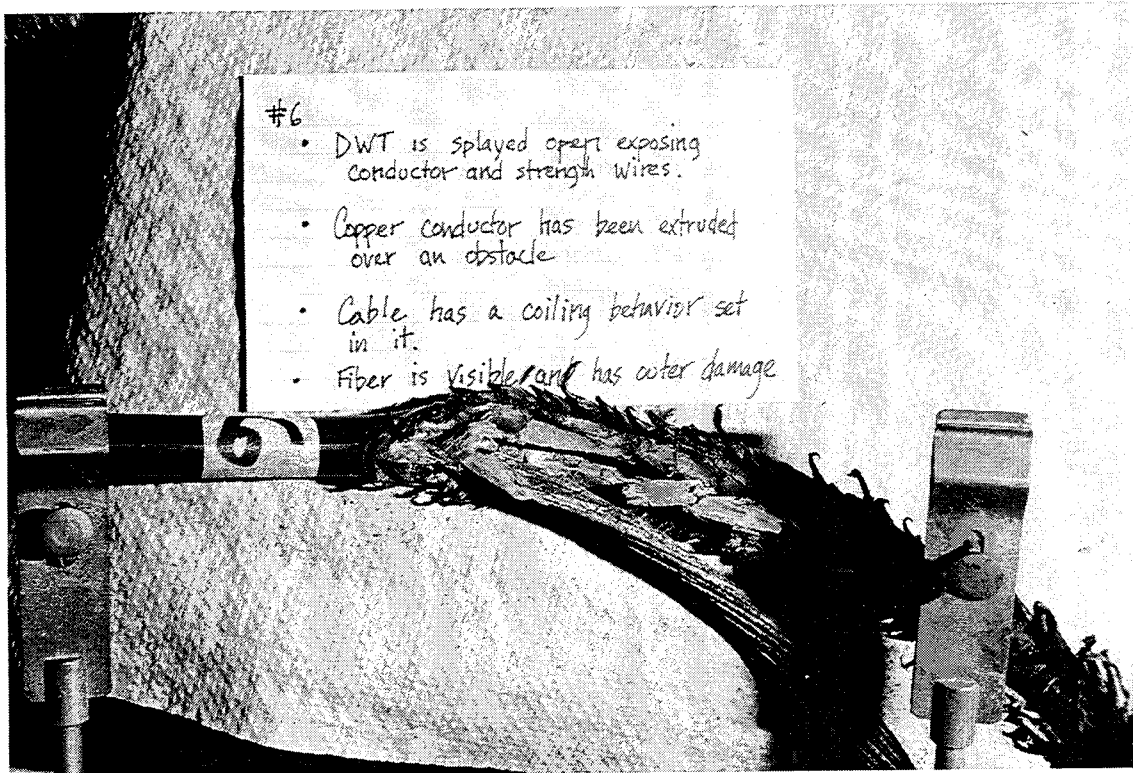
5.8 Fault Number 6 - FDS-D CABLE AUTOPSY WORKSHEET

Condition of Optical Fiber Sheath: The sheath is shredded exposing the buffer. Indentations from where the strength wires deformed the buffer.

Condition of Fiber: There appear to be kinks and bends in the core. Obvious catastrophic failure.

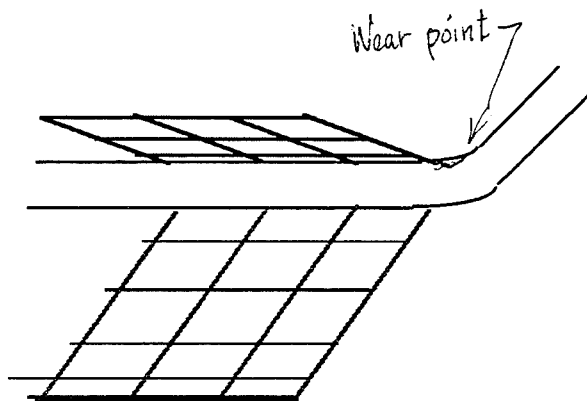
- Copper conductor is ruptured exposing strength wires.
 - Back side of fault area has been worked. Appears to have exceeded elastic limit when bent and buckled upon straightening.

- Cold flow and tearing to outer jacket.
 - Cable bent at a 30° angle where it contacted filter screen.
